Imperial College
BUILDING BRIDGES 2006
Expedition Report

NORTHERN MALAWI

To build a footbridge across the North Rukuru River near Uledi.

***An expedition to construct a suspended bridge
across the North Rukuru River on the
north western edge of the Nyika National Park,
near Uledi in Northern Malawi.***

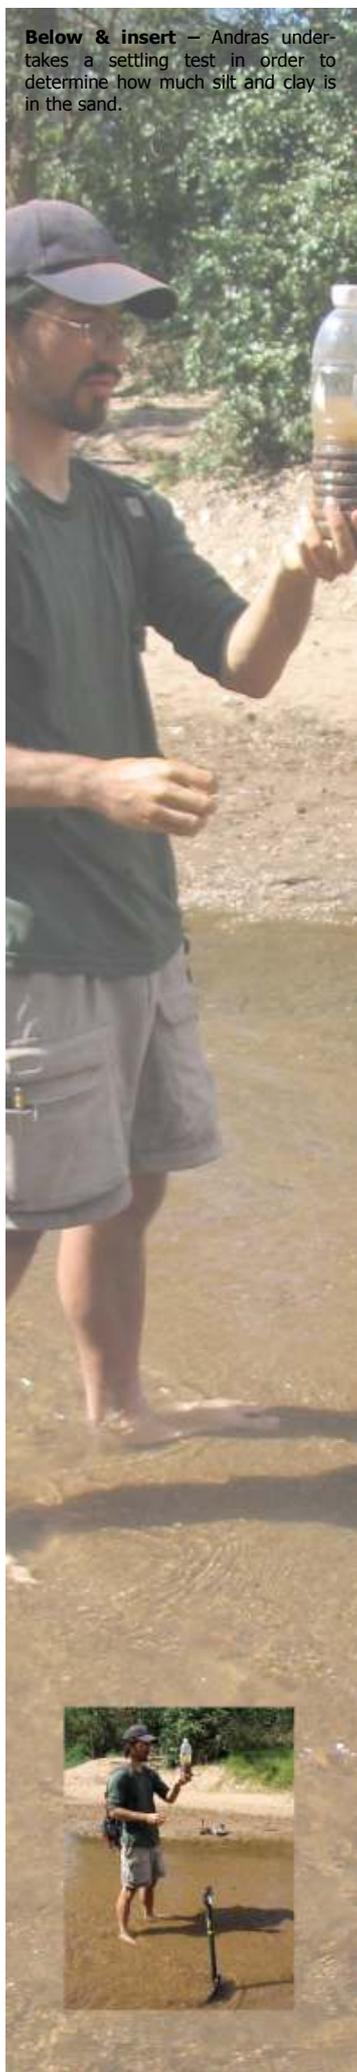
Below & insert – Andras undertakes a settling test in order to determine how much silt and clay is in the sand.

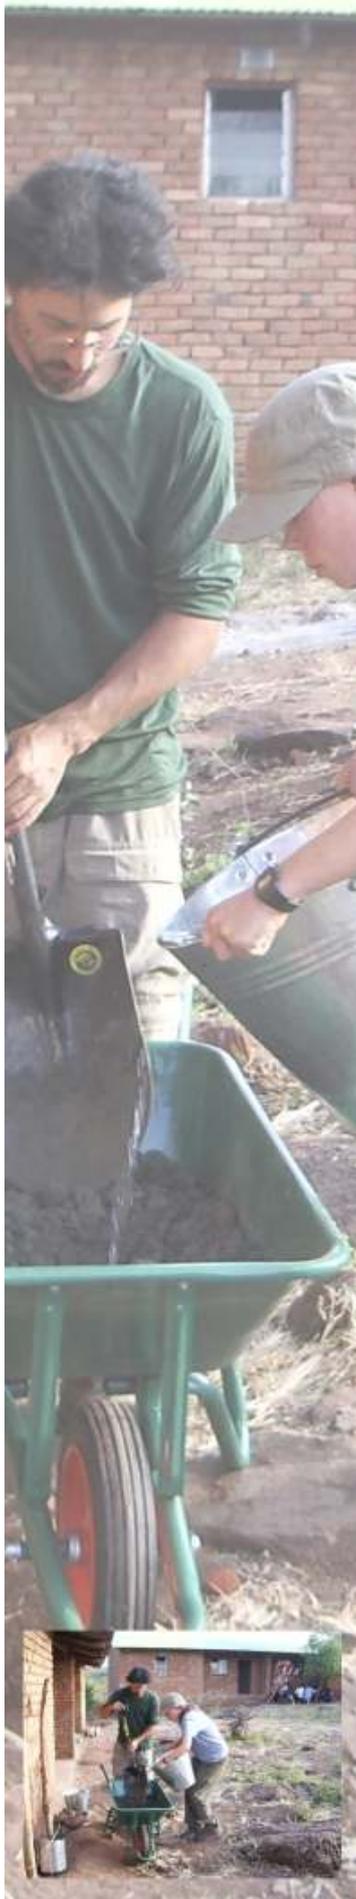
Below & insert – Andras mixes a test batch of concrete while Naomi pours some water in.

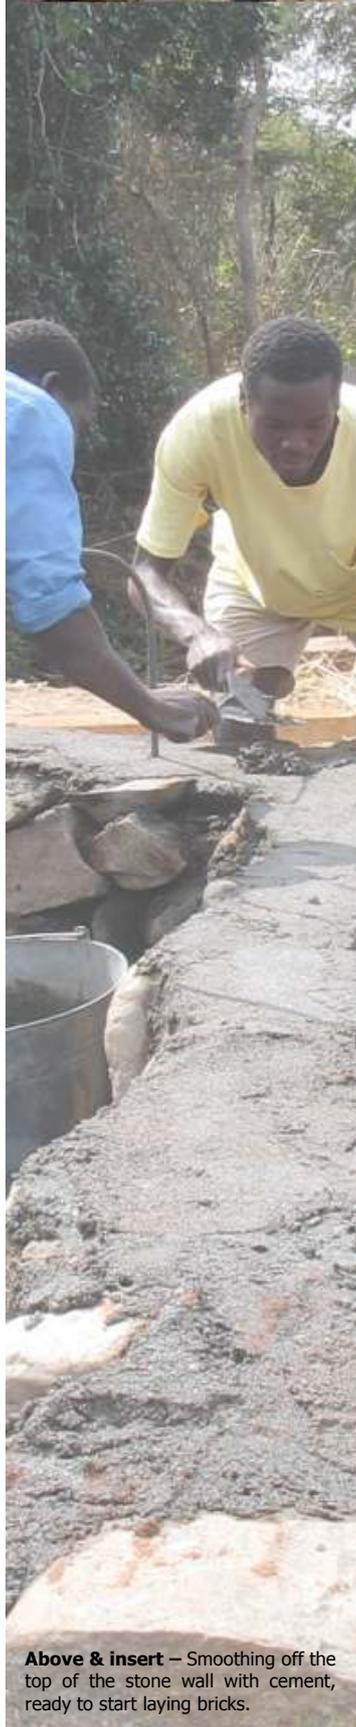
Above & insert – Smoothing off the top of the stone wall with cement, ready to start laying bricks.

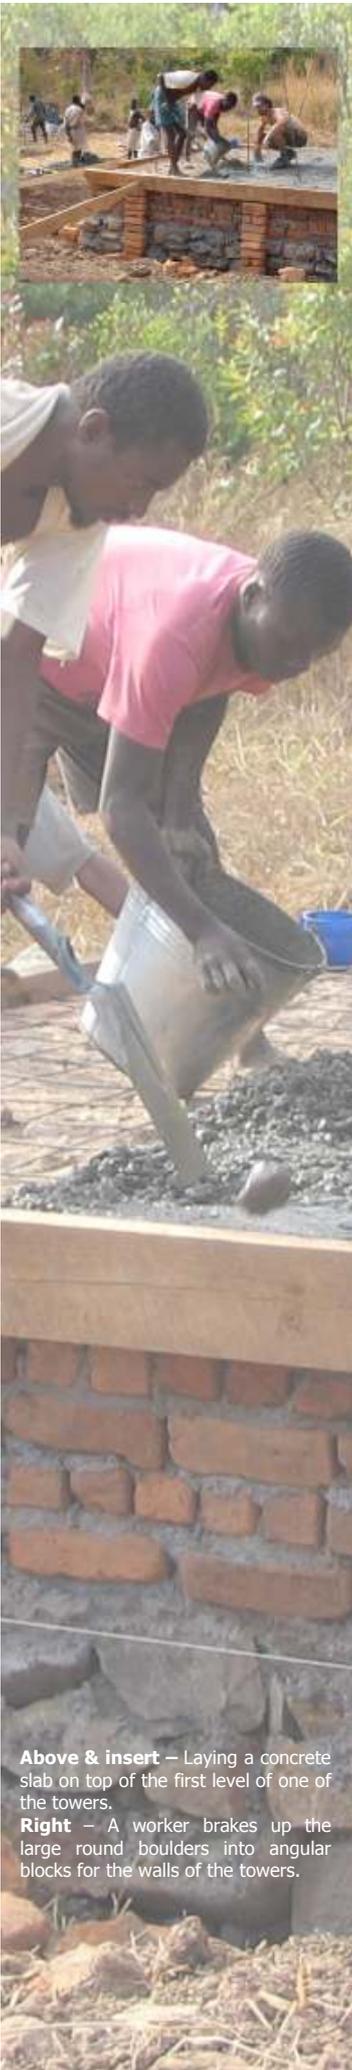
Above & insert – Laying a concrete slab on top of the first level of one of the towers.

Right – A worker brakes up the large round boulders into angular blocks for the walls of the towers.

Once the tower foundation pits had been dug work began on constructing the towers. The foundations were constructed flush against the pit wall. Hammered rocks held together with mortar were used for the walls. The space between the walls was filled with large boulders from the river which were packed in with sand and stones. This fill was laid and packed as tightly as possible, to give it the best possible chance of spreading the load and transferring the weight to the ground below.

The broken boulders were laid by two community members, who showed some skill, enthusiasm and diligence towards this task. Laying the broken pieces within the foundation was relatively easy. These broken boulder walls were constructed to just above the highest flood level - a height of about 50cm above the height of the surrounding ground - as it was felt if bricks were used at this lower level they would quickly weather and the tower could be weakened. In this portion of the tower it was extremely difficult to lay the irregular rocks consistently. Bricks were used above this level for the tower walls and this increased the speed of the construction considerably as, whilst not wholly regular or standardised, the bricks were at least roughly square and of similar size to one another. Double and in places triple layer brick walls were built to give the tower's walls extra strength, and these too were held together with mortar. The towers were built in one metre high tiers, which were filled with boulders and sand. This sand was compacted by hand before the whole tier was topped off with a 50mm thick mesh-reinforced concrete slab. The concrete mix used for these slabs was one batch of cement to 1.7 batches of sand and 3.5 batches of gravel. These RCC slabs provided strength to the towers at each level and additional reinforcement was placed vertically from foundations up to the top level to protect against any sideways forces which may be imposed on the bridge, for example if something were to get stuck under the bridge. Two handrail columns formed the top level of each tower. These were constructed from single layer brick walls filled with concrete. RCC saddles were put on top to spread the weight of the cable.

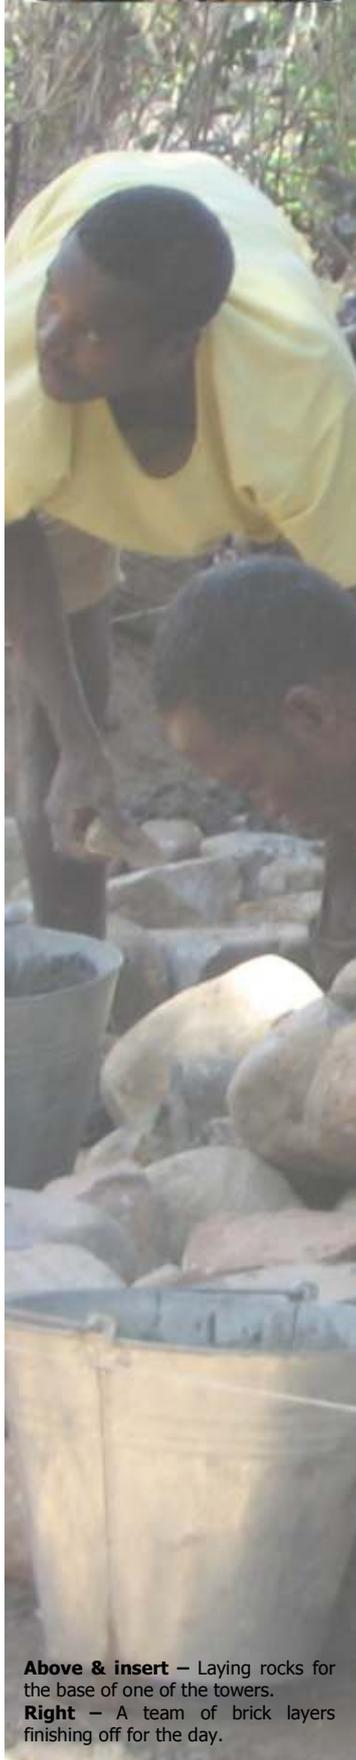
Above & insert – Laying rocks for the base of one of the towers.
Right – A team of brick layers finishing off for the day.

Below & insert – Andras using duct tape to seal up the pipe in the cage before the pit is filled with concrete.

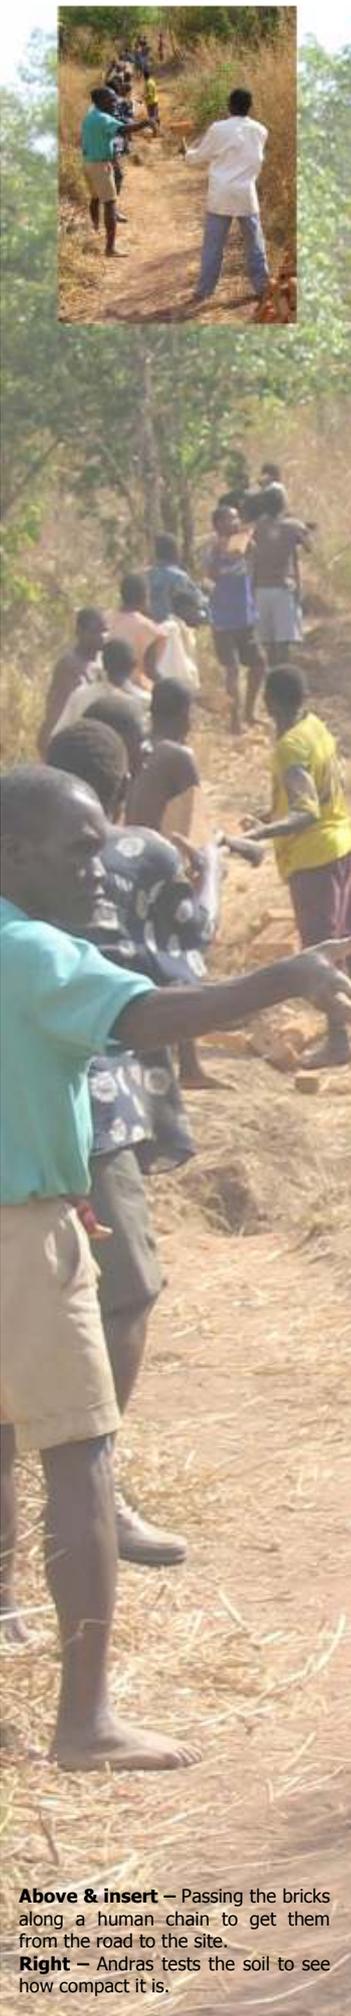
Above & insert – Passing the bricks along a human chain to get them from the road to the site.
Right – Andras tests the soil to see how compact it is.

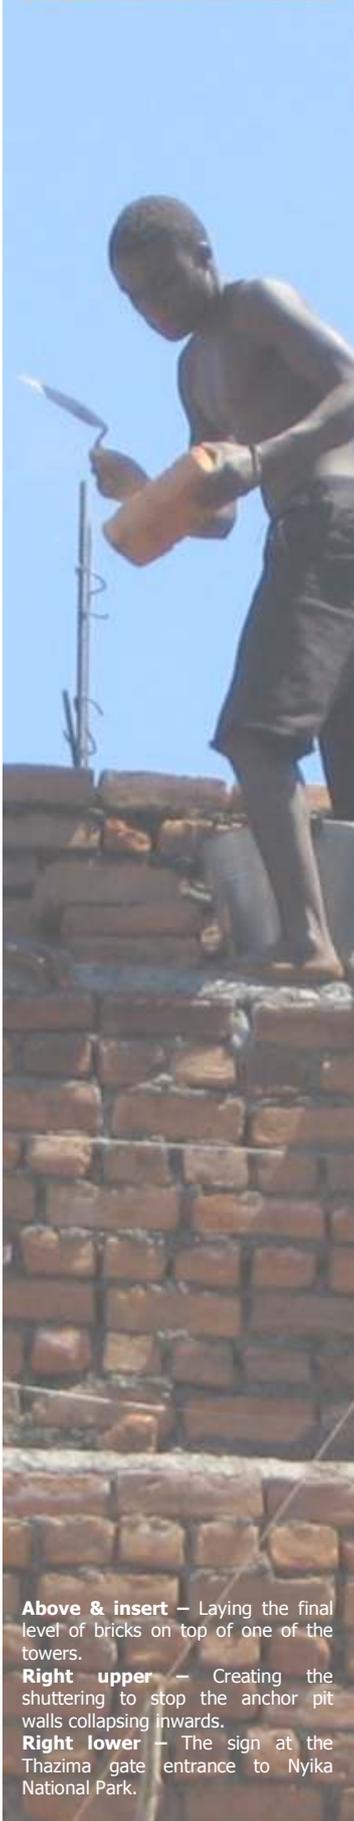
Above & insert – Laying the final level of bricks on top of one of the towers.
