An expedition to complete the construction of a footbridge across the North Rukuru River at Uledi, on the north western corner of the Nyika National Park, in Northern Malawi.

BUILDING BRIDGES 2007

Expedition Report

To complete the construction of a suspended footbridge across the North Rukuru River near Uledi, and to protect the adjacent river bank.

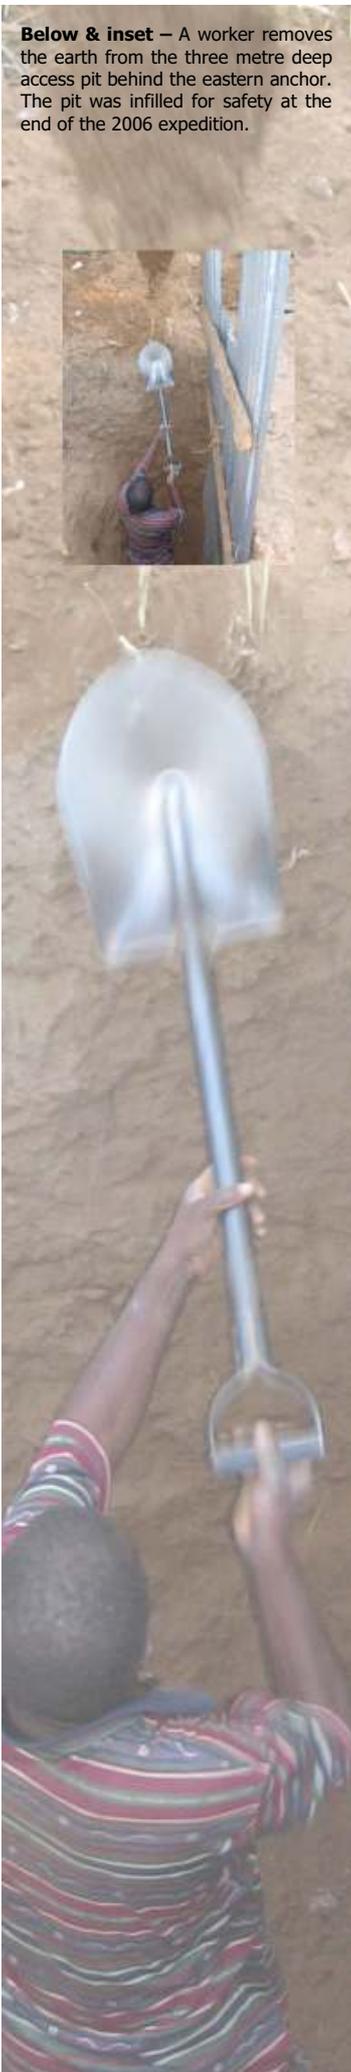
Below & inset – A worker removes the earth from the three metre deep access pit behind the eastern anchor. The pit was infilled for safety at the end of the 2006 expedition.

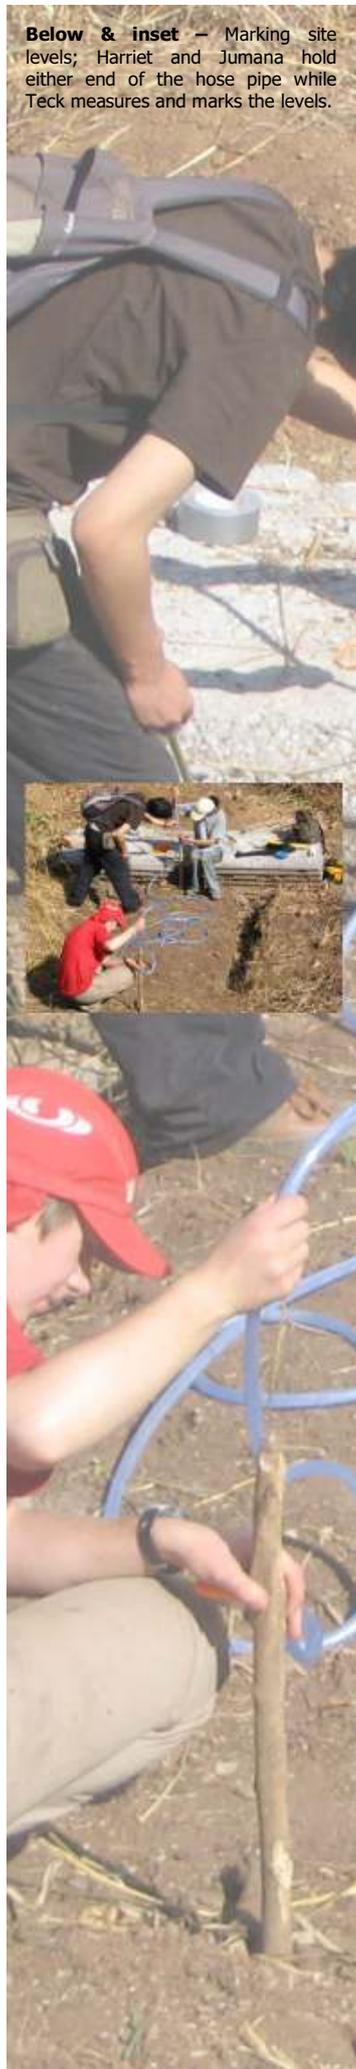
Below & inset – Marking site levels; Harriet and Jumana hold either end of the hose pipe while Teck measures and marks the levels.

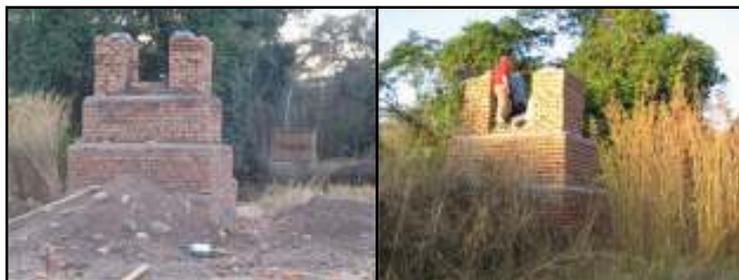
When the team arrived in Uledi, the site was overgrown with long grass up to eight feet high on the west bank (fig. 1) and thick dense bush vegetation on the east bank. The site had been cleared of all vegetation the previous year and so the re-establishment of plants was an encouraging sign, as it showed the flora quickly re-colonised the area. This would help protect the river banks and the embankment once construction was complete. However, it did mean the site had to be cleared again before any work could begin, which was not an easy task.

Fig. 1 – The site cleared in 2006 (L) and overgrown upon arrival in 2007 (R)

Once the site had been cleared, a visual check confirmed that the earth slopes built around the towers in 2006 were present, in good condition, and did not appear to have suffered much from the annual flooding during the rainy season. The towers also showed no obvious cause for concern, with the mortar and brickwork intact and no cracks visible. When the corrugated sheeting was removed from the back of the anchor block on the east side, some steel reinforcement was found to be exposed. This did not appear to have corroded and was simply noted for correction when concreting later on.

Four local men were employed on the first day to clear the ground around the towers using pangas (machetes) and hoes. They then cut back and cleared the vegetation on both sides of the narrow paths which led from the camp to the bridge site and to the river. On the west grassy side the work was fairly easy. However, on the east side the workers had to do battle with "buffalo beans", a seed pod that hangs from bushes and is covered in small spines which are released when touched or knocked and cause severe skin irritation. Areas were also cleared on both sides of the river for storing construction materials; namely sand and gravel for concrete, and large stones for bulk fill. The access pit behind the anchor block on the east bank was unearthed and the corrugated steel shuttering which had been left in place the previous year was removed.

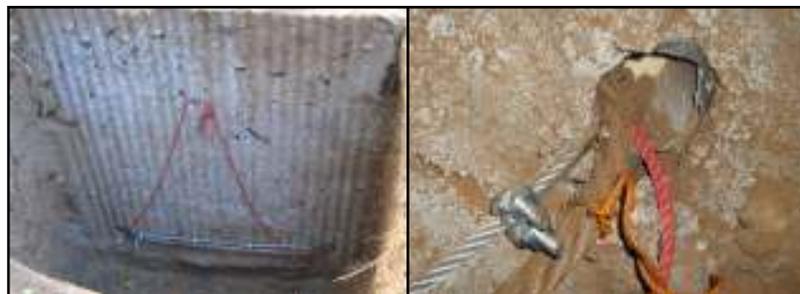
The leading half of the handrail cable was installed across the upstream side of the bridge. It was first fed through the anchorage on the east bank (fig. 2), and then taken up over the upstream side of the saddle on top of the east tower before being manhandled down the east river bank and out across the river where a static rope was attached to the cable using bulldog grips. This rope was fed up over the saddle on the west tower, and used to pull the cable into position. Once in place, the rope was used to tie off the cable to the steel loop embedded in the western anchor block. The free end of the cable was then under no tension, and could be fed through the pipe in the anchor block and tied off to itself using bulldog grips. Installation of the other half of the cable took place on the downstream side of the bridge in much the same way. After being fed through the anchor on the east bank, the cable was laid over the east tower before being pulled across the river, the west tower and fastened in place at the western anchor. The handrail cable was left overnight with the static ropes still attached for safety.

Fig. 2 – Access pit behind the eastern anchor block (L) and close up of the cables running through the plastic pipe set in the anchor (R). The red rope was left running through the plastic pipe to prevent it becoming blocked. The orange cord and grips mark the middle section of the walkway and handrail cables respectively.

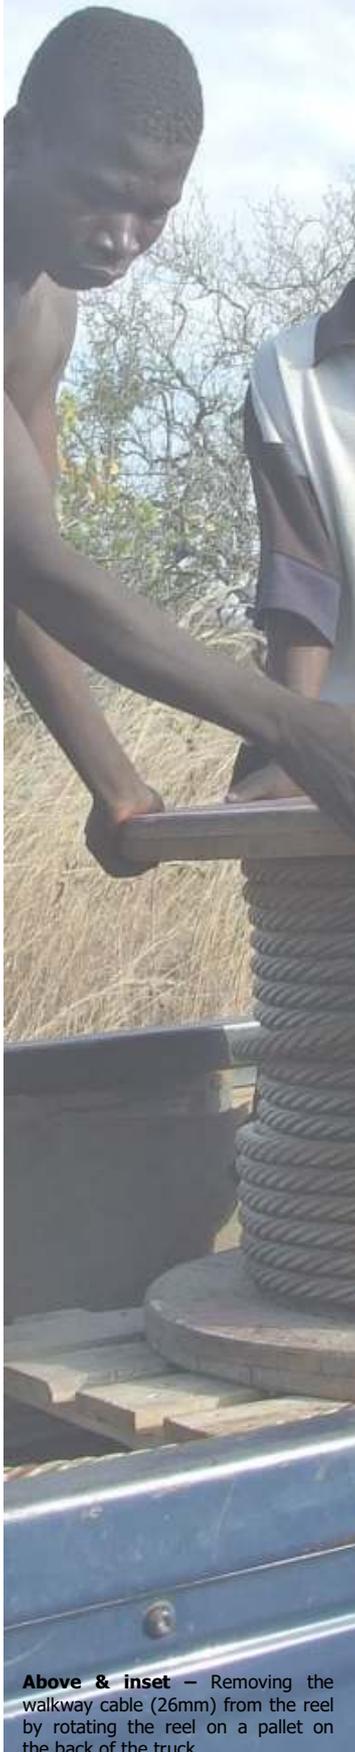
Above & inset – Removing the walkway cable (26mm) from the reel by rotating the reel on a pallet on the back of the truck.

An 11 mm handrail cable and a 26 mm walkway cable were used to span the river and form the basis of the suspended footbridge. Both cables were 130 m in length and were transported to Uledi on large wooden reels. A number of different methods for removing the cables from the reels were considered to ensure the cables were not damaged or twisted during this process. The handrail cable was unrolled and installed first due to it being lighter in weight and thus easier to handle. The reel was placed on the back of the truck, which was driven a hundred odd metres up the straightest stretch of road closest to the site. Three workers then dragged and rotated the reel on the back of the truck, while other workers took the end of the cable and walked away from the truck back down the road. Thirty workers were spaced out evenly along the length of the cable, every five metres or so, to spread the weight. Once off the reel, the cable was laid down and measured, and the mid-point was marked with tape. The cable was then carried on the workers' shoulders, and walked across the river. Great care was taken to avoid twisting or scraping the cable on the ground, both of which would have damaged the cable.

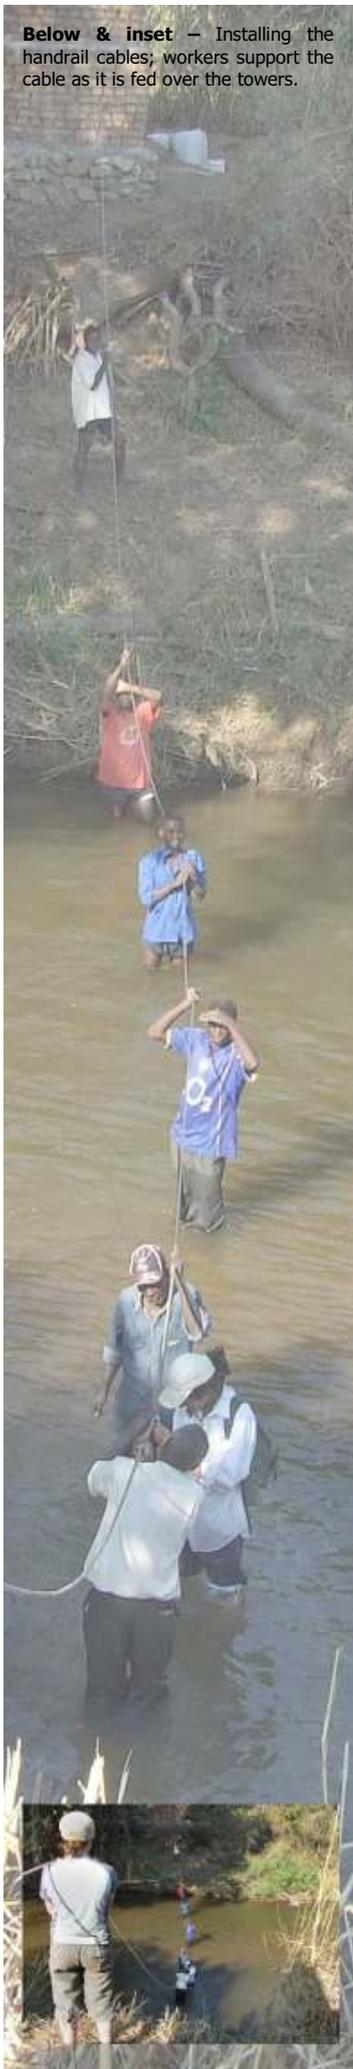
Below & inset – Installing the handrail cables; workers support the cable as it is fed over the towers.

before being relaxed to their final correct position. This position was calculated using the Helvetas guide, and lines were painted on the west tower to show the final hoisting level. One member of the team was positioned on the opposite bank, and sighted across so that the lowest point of each cable could be lined up with the relevant painted line.

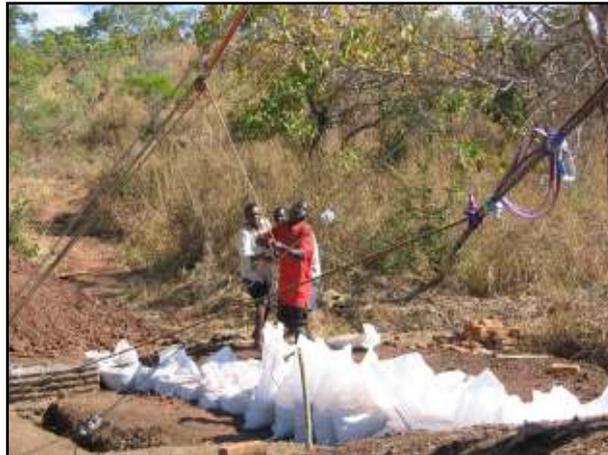
Fig. 3 - Three workers haul the walkway cable (right) over the west tower.

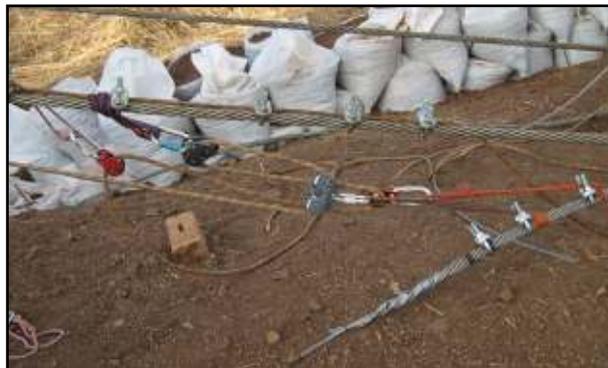
The 26 mm walkway cable was tensioned using two three-way pulley systems (*fig. 4*) used in tandem, each with a safety ratchet which only allowed the rope to be pulled in one direction and prevented it slipping back if let go. In addition a safety rope remained locked off and attached to the cable at all times, thus preventing the cable from falling back to the ground, should the safety ratchet have failed. Once the safety rope and pulley system had been set up, the grips which fastened the cable to its self were undone and six men used the pulley system to raise the cables into position. When the cable was at the correct level, the grips were then tightened. Communication between the observer and the workers pulling the cables was difficult, and the cables were very sensitive, so a certain amount of trial and error was required. The handrail cables were tensioned in a similar way. However, being lighter, not so much man power was required. Two team members carried out the task using just one three-way pulley system.

Fig. 4 – Three way pulley system used to tension the cables. An 11 mm static rope was used in the pulley system and attached to the 26 mm cable using grips. The end of the cable, which was tapered in order to feed it through the anchor block, can be seen in the foreground.

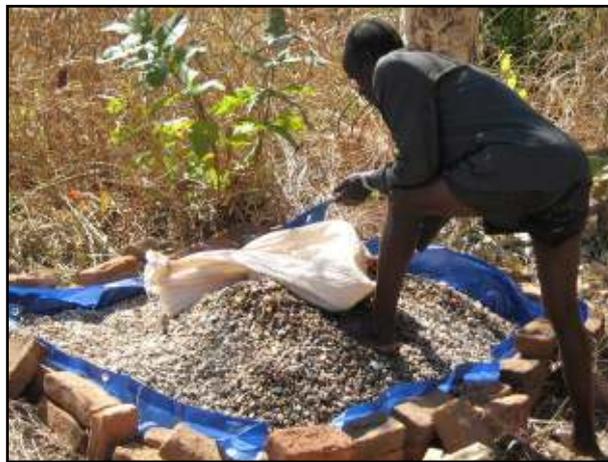
Fig. 5 – A worker empties his sack of aggregate onto the stockpile on site

All the aggregate, sand and water was transported to assembly points on each bank, so that when the time came for concreting all the materials were close by and to hand. Sand and aggregate were laid out on tarpaulins to keep them separate from the dusty ground and to allow them to dry out in the sun (*fig. 5*). The water drum was covered to prevent evaporation when not in use. And the cement was kept in a cool dry storeroom and only carried down to the site on the day when it was to be used.

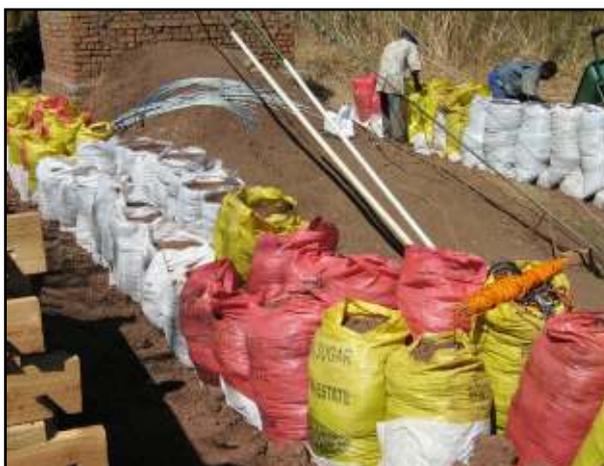
Fig. 6 – Construction of the retaining walls on either side of the west tower. Note the vertical offset in height between the front and back row of sacks in each wall.

First the foundations for the retaining walls were dug. Trenches 1 m wide and 50 cm deep were dug from behind each side of the tower back as far as the anchor, in order to remove the topsoil. In these trenches local woven plastic 50 kg sugar sacks were filled with earth. Two rows of filled sacks were placed in each trench (fig. 6) with the sacks in the front row offset compared to those at the back. This lateral offset helped the rows of sacks interlock thus maximising the wall's stability and the protection it offered. The front row of sacks in each trench was two-thirds filled with earth while the back row was only one-third filled. Additional layers of sacks all filled two-thirds full of earth were placed on top and offset inwards towards the embankment to build up the height of the retaining wall and give it an inclination angle of

about 60°. The offset created between the front and back row of sacks in each layer (*fig. 6*) gave the retaining wall strength. Finally 8 mm reinforced steel was cut into 1 m long stakes and hammered through the sacks at an angle to hold them together and to stop the wall peeling away from the embankment.

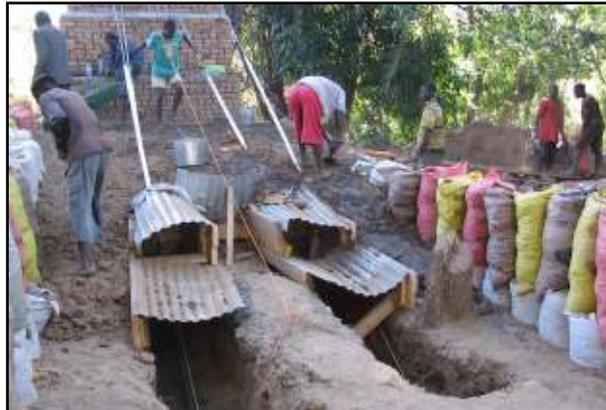
The area between the two retaining walls on either side of each tower was filled in with earth, in between each layer of sacks which were added to the top of the retaining wall. This earth was ferried in from the neighbouring stockpile by whatever means possible i.e. in wheelbarrows, shovelling it directly and carrying it in sacks (*fig. 7*). The earth was spread out evenly until it formed a 20-30 cm thick unconsolidated layer, which was sprinkled with water. The workers then repeatedly danced, jumped and trod all over the moist earth to compact it (*fig. 7*). Another compaction method used involved repeatedly hitting the damp earth with the backs of shovels. Although crude, these compaction methods were relatively good given that using a mechanical device was not possible. Once the laid earth was compact, more earth was ferried in and the same process repeated until the earth fill reached the height of the sacks. The embankment was built up against the back of each tower and landscaped so it sloped down to ground level behind each anchor. When the final layer was placed the embankment had been built up to a height of 1.5 m adjacent to the tower.

Fig. 7 – Building the embankment. Earth brought from stockpile (right) by wheelbarrow and sacks was spread out with hoes and compacted by hitting with shovel or jumping up and down on it (man to the right of wheelbarrow).

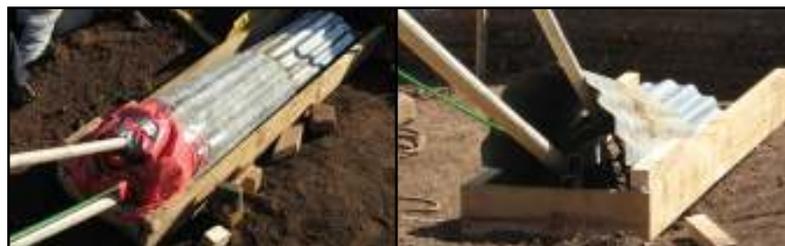
Shuttering was built up around the parts of the cables within the embankment in order to keep the earth fill out of the trenches in which the cables lay. This shuttering was made out of spare timber and the left over corrugated steel sheeting (*fig. 8*). A lack of appropriate timber meant the shuttering was not as effective as it should have been. Once the back fill was complete the shuttering was removed, and the trenches dug out and cleared of loose earth where needed. The trenches were then filled with concrete to set the cables in place. First concrete was fed in to the plastic tubing in which the cables lay inside the anchor block. Then the trenches were filled with small rocks and concrete; with the rocks providing bulk in the trenches and the concrete being used to cover the cables and hold the rocks together (*fig. 9*). The parts of these cables which fed around the back of the eastern anchor block (*fig. 2*) were also covered with concrete, as were any exposed bits of rebar in the anchor block. The concrete was left to cure for three days and the bridge was not touched during this time to avoid compromising the concrete's strength.

Fig. 8 – The shuttering placed around the cable trenches to keep earth out while building the embankment. Plastic pipes were also placed around the cables themselves to protect them.

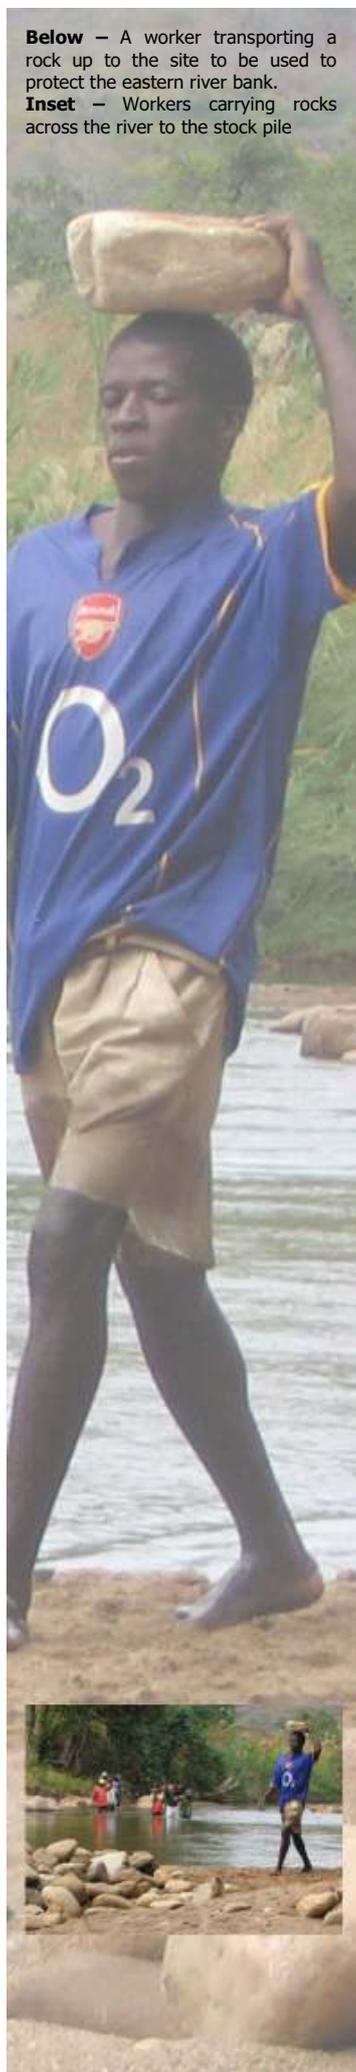
Fig. 9 – Setting the cables in concrete. Boulders were placed down the sides of each trench to reduce the volume of concrete required.

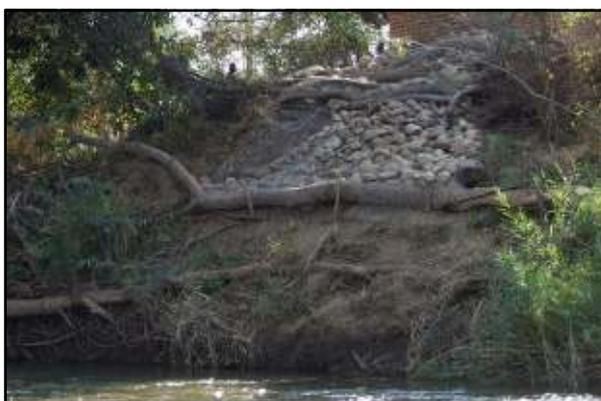
Fig. 10 – The eastern river bank protection. The idea came from natural protection offered by fallen trees and large roots behind which river deposits had accumulated. One such root naturally protecting the bank can be seen running across the lower bank in the foreground.

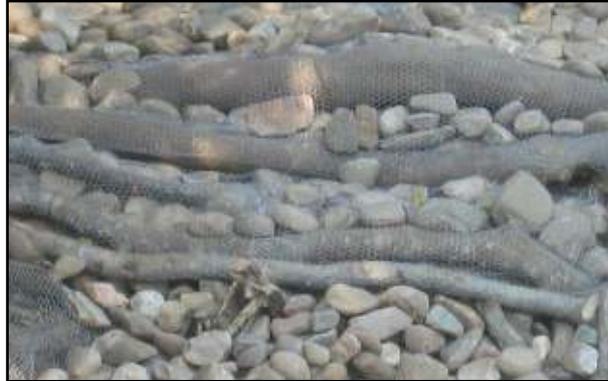
Fig. 11 – River bank protection on the east side. Logs were staked along the bank, rocks placed behind them and wire mesh used to cover them.

so that they did not move around. They were then covered with wire mesh to stop them being lifted up. This process of laying a large log, filling the area behind with rocks and covering it all with wire mesh was repeated up slope by taking advantage of the natural shelves in the river bank where possible (*fig. 11*). Each subsequent log was placed on the wire mesh that covered the rocks below so as to secure the mesh in place. The protection was built right up to the foot of the east tower where the wire mesh was held down by placing a load of large boulders on it around the base of the tower. Finally the front of each wire mesh was bent and nailed around the front of the logs before being trimmed (see bridge plans sheet 4).

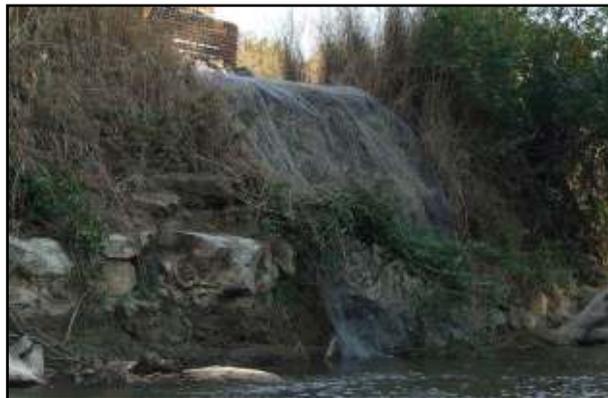
Fig. 12 – Wire mesh placed over the west bank to hold loose blocks in situ, thus protecting the bank from erosion.

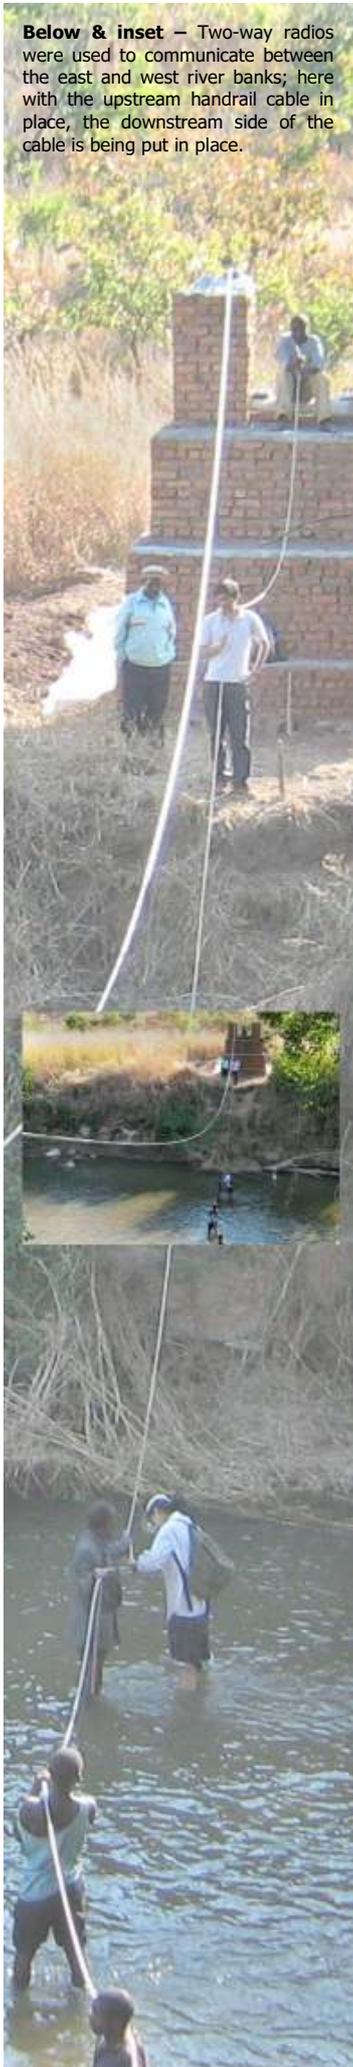
Below & inset – Two-way radios were used to communicate between the east and west river banks; here with the upstream handrail cable in place, the downstream side of the cable is being put in place.

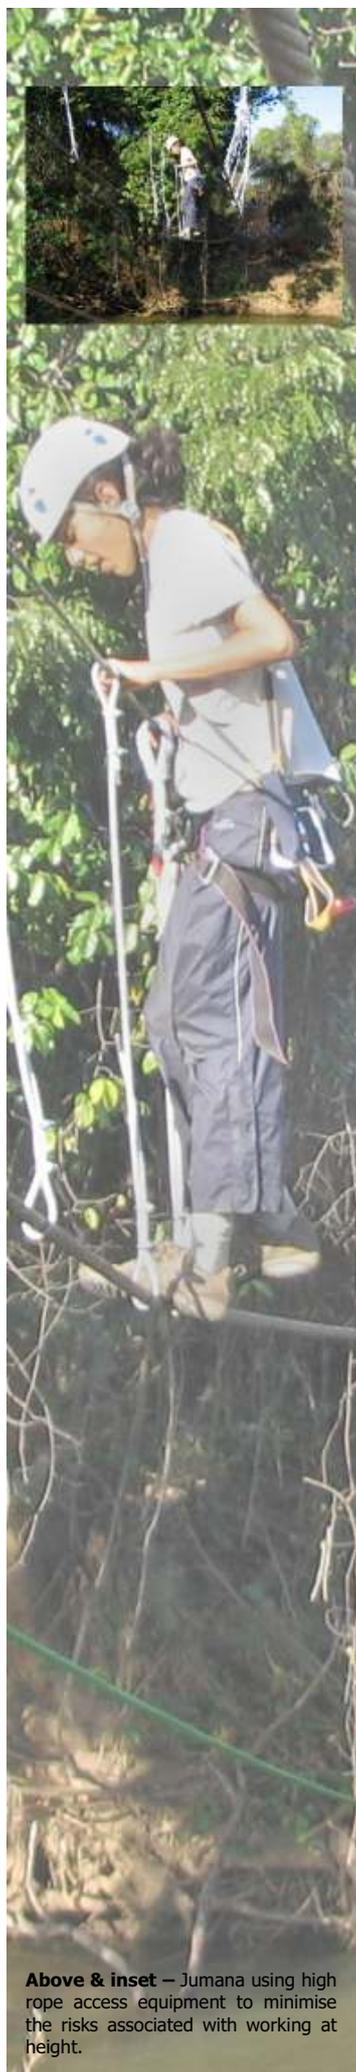
Above & inset – Jumana using high rope access equipment to minimise the risks associated with working at height.

Once the cables had been fixed in place, team members walked out along the cables to affix the suspender cables and lay the decking. Team members who did this were required to use specialist high ropes access equipment which involved wearing a climbing harness and clipping onto the handrail cable using two karabiners on the end of two lanyards attached to each harness. The two lanyards enabled team members to safely pass obstacles on the cable by unclipping one karabiner and re-clipping it past the obstacle, before unclipping the second karabiner and doing the same with this. In this way team members could safely move past suspender cables which linked the handrail and walkway cables, while always being secured to the handrail cable by one karabiner. Helmets and chest harnesses were also provided. Decking units were also attached by slings to the handrail cable while they were being walked into position, so if dropped they would not fall off the bridge. All team members were shown how to use this high ropes access equipment and were initially supervised by Naomi who was competent with these techniques. No more than two team members were allowed on the cables at any one time and where possible the two team members clipped onto different cables to avoid the potential of overloading one particular cable. Four complete sets of high ropes access equipment were taken to Malawi, despite the fact only two people were allowed on the cables at any one time. This was so that if those working got into difficulty there was enough equipment on site for other team members to safely rescue them.

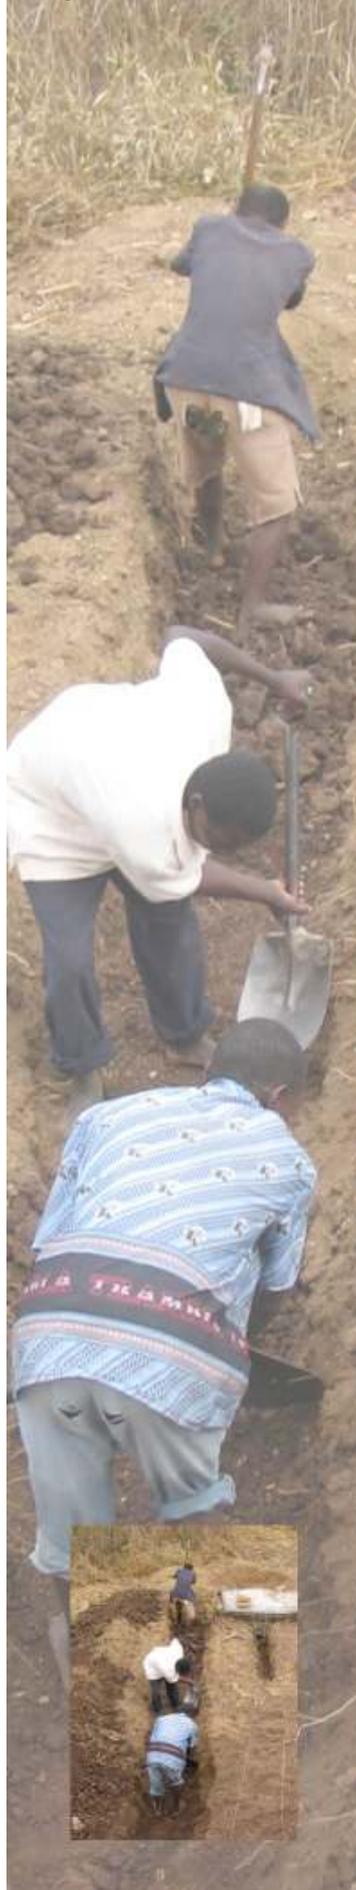
Below & inset – Digging the foundations for one of the retaining walls; four of these trenches were dug in total.

Inset – The top of the concrete anchor block can be seen in the background.

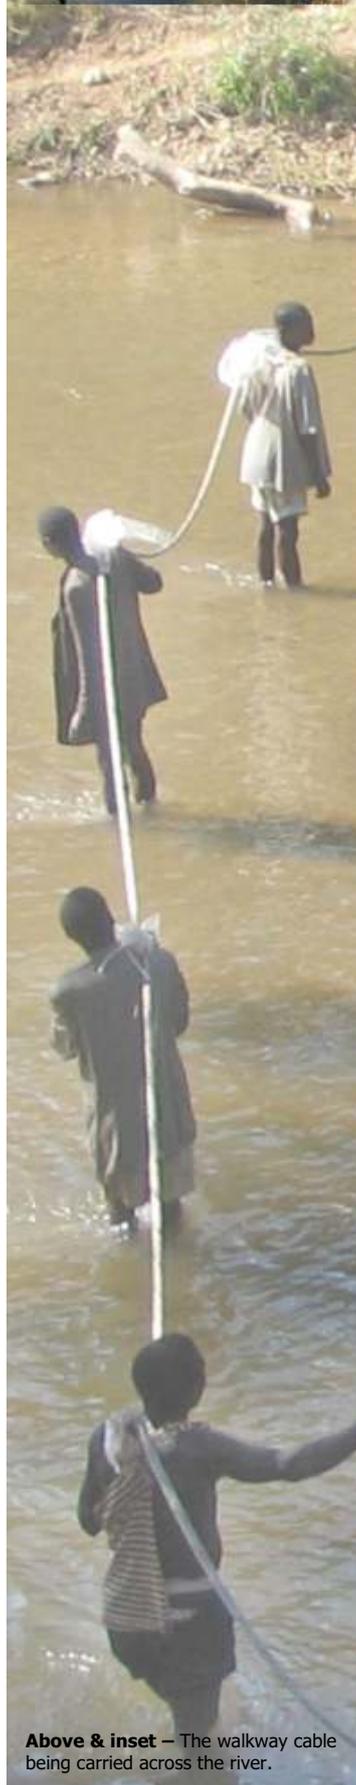
Above & inset – The walkway cable being carried across the river.

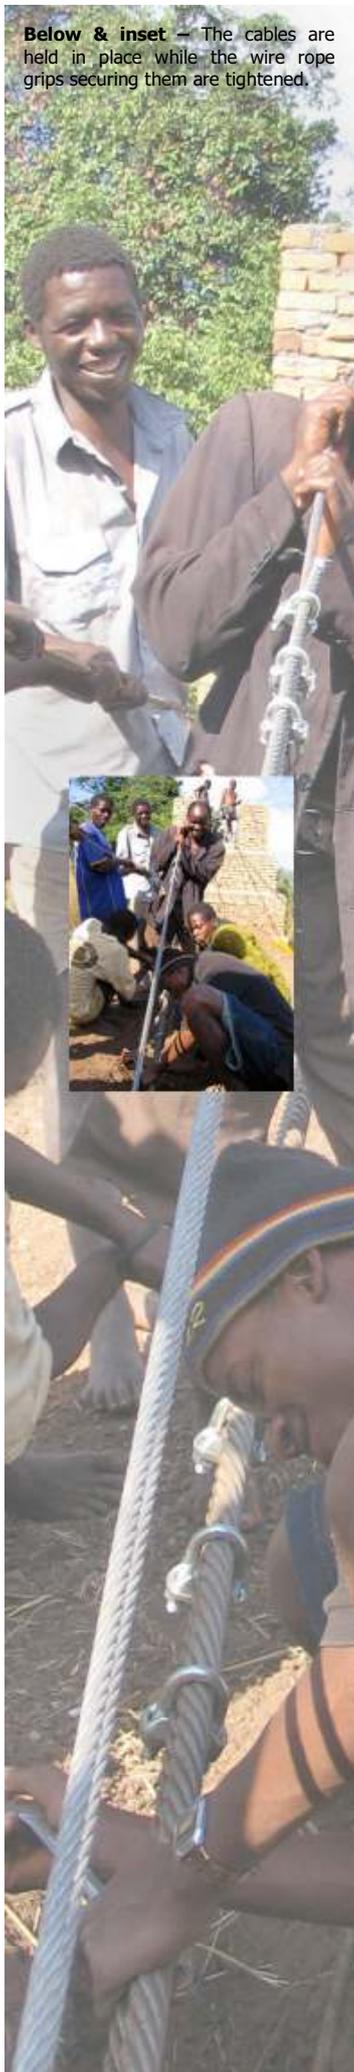
Below & inset – The cables are held in place while the wire rope grips securing them are tightened.

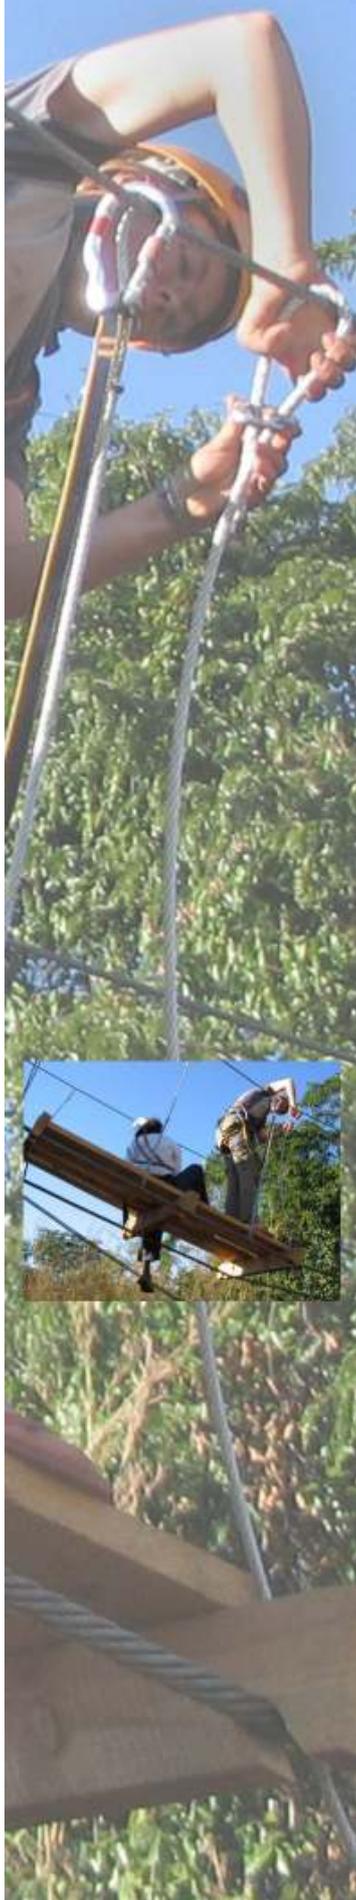
Below – Naomi fastens a wire rope grip around a 10mm suspender cable to secure it in place.

Inset – Jumana helps Naomi by attaching suspender cables on the other side.

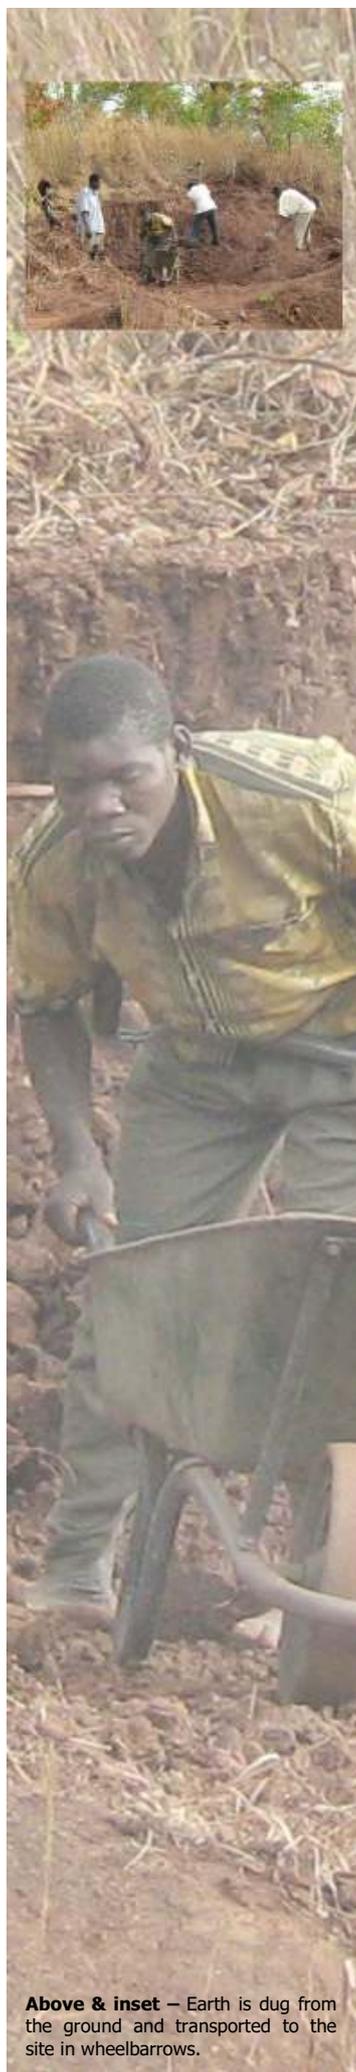
Above & inset – Earth is dug from the ground and transported to the site in wheelbarrows.

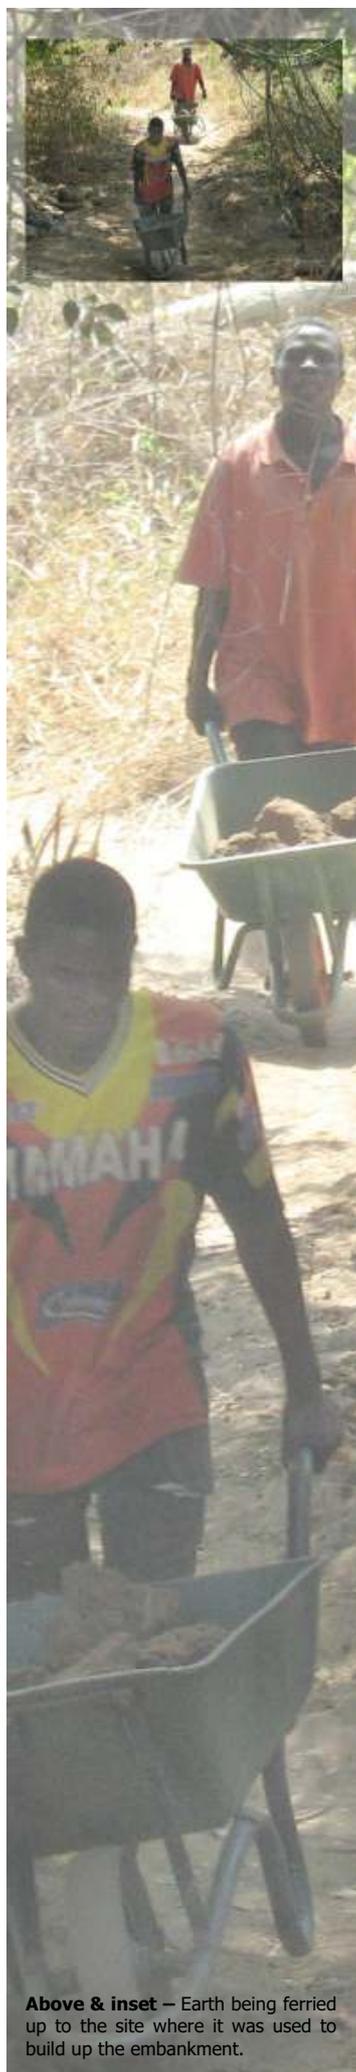
Above & inset – Earth being ferried up to the site where it was used to build up the embankment.

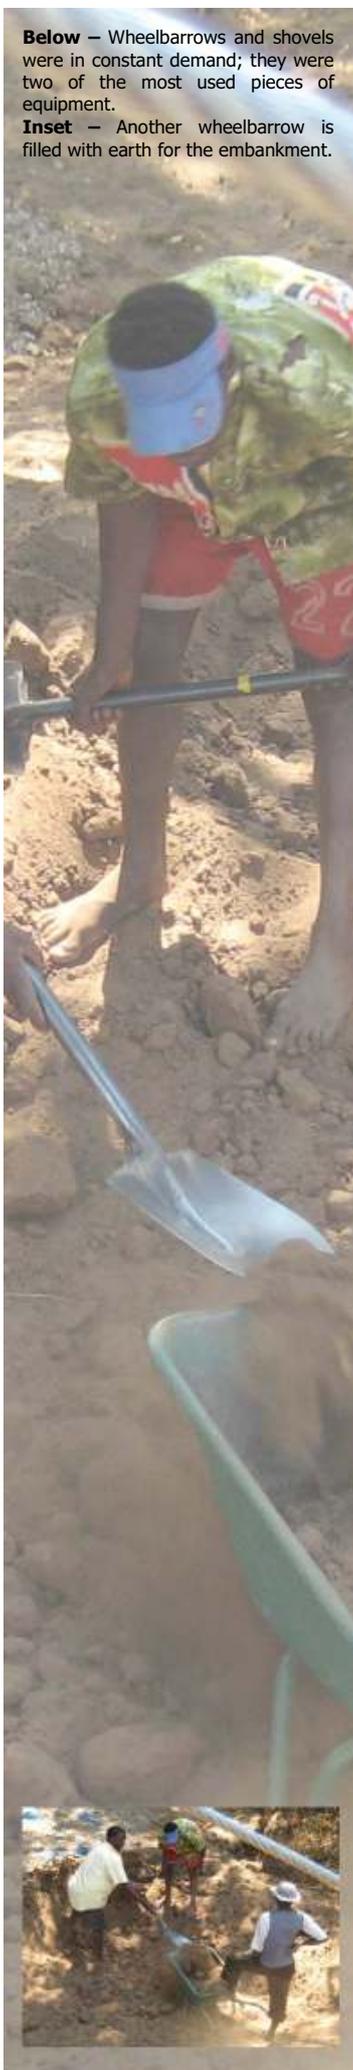
Below – Earth is shovelled into a wheelbarrow from the stockpile so it can be added to the embankment.

Inset – Workers use their feet to compact the earth (foreground) while more earth is brought down to the site (background).

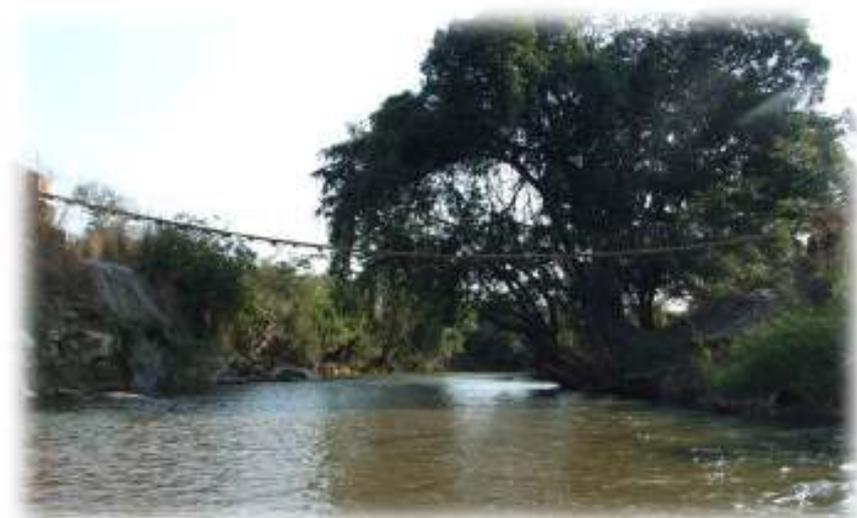
Right – The finished bridge looking downriver; the protection of the east (R) and west (L) banks can just be seen in front of the towers.
